MARYLAND INVENTORY OF HISTORIC BRIDGES HISTORIC BRIDGE INVENTORY MARYLAND STATE HIGHWAY ADMINISTRATION/MARYLAND HISTORICAL TRUST

MHT No. <u>PG:67-29</u>

SHA Bridge No. P-189 Bridge name Sunnyside Avenue over Indian Creek
LOCATION: Street/Road name and number [facility carried] Sunnyside Avenue
City/town Beltsville Vicinity X
County Prince George's
This bridge projects over: Road Railway Water X Land
Ownership: State County X Municipal Other
HISTORIC STATUS: Is the bridge located within a designated historic district? Yes NoX National Register-listed district National Register-determined-eligible district Locally-designated district Other
Name of district
BRIDGE TYPE: Timber Bridge: Beam Bridge: Truss -Covered Trestle Timber-And-Concrete Stone Arch Bridge
Metal Truss Bridge
Movable Bridge: Swing Bascule Single Leaf Bascule Multiple Leaf Vertical Lift Retractile Pontoon
Metal Girder X : Rolled Girder X : Rolled Girder Concrete Encased : Plate Girder : Plate Girder Concrete Encased :
Metal Suspension
Metal Arch
Metal Cantilever
Concrete: Concrete Arch Concrete Slab Concrete Beam Rigid Frame Other Type Name

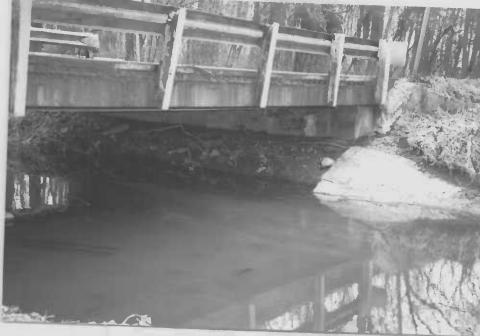
7. East abutment

According to the 1995 inspection report, this structure was in fair condition with spalling, rusting and section loss. The deck has spalls with areas of exposed reinforcement bars on the wearing surface. The corrugated steel plate is heavily rusted with section loss. The guardrails have areas of 100 percent section loss and the west end of the south railing is missing posts as a result of a vehicular accident. The steel girders have moderate rust, scaling and up to 25 percent section loss in the web and 60 percent loss in the bottom flange. Both abutments have spalling, cracking and efflorescence below the girders. The concrete in the abutments under the exterior girders is severely cracked and loose.
